Application Case Study – TRW Automotive, Shanghai, China

Automated vision inspection and parts traceability in automotive assembly process

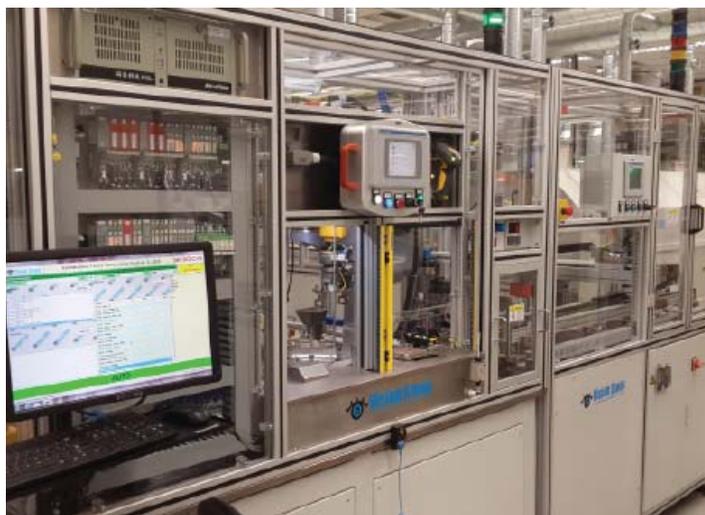
Vision Stone developed and installed a custom-made vision inspection system for TRW with multiple smart cameras from Microscan.

Vision Stone installed the new assembly line at TRW, consisting of two rotary tables. One of the tables is used for components assembly, while the second table combines the cover plate with the correct housing once all the components are assembled. The new design makes efficient use of robotic arms to save space, while being easy to maintain. The operators simply need to place the parts onto the assembly line and pick up the complete products after assembly.

In the assembly process, five feeders transport five different components to be processed. The QX Hawk industrial imager reads the code on the housing, and three robotic arms are used to place the components into the housing. The machine vision system then checks the quality and makes sure that the product is assembled correctly.

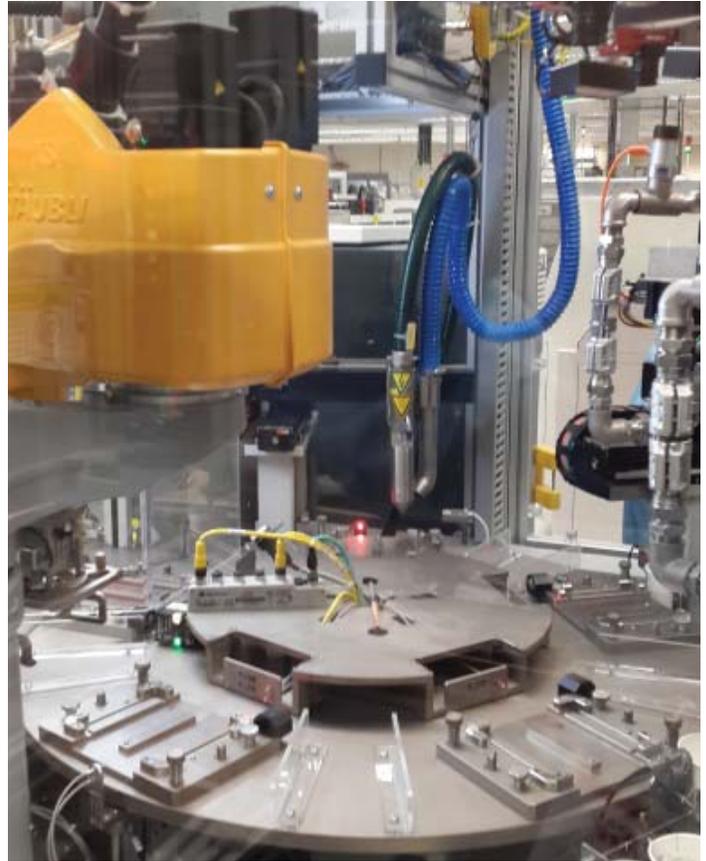
Microscan's Vision HAWK is integrated into a robot arm for vision inspection on the assembly line.

It checks that there are no air bubbles in the glue used for sealing to ensure coating integrity, before the products go into the oven.

In addition to making sure that the individual components are inserted into their correct positions, the vision system checks the solder position, the sealant and cooling gel position, and gel coverage rate on the cover. The cooling gel coverage is vital as too little of it will cause the parts to become too hot, and too much gel will affect the appearance. The components are also inspected to test for polarity, positioning or damage. The solder inspection is very important because if the stitch is even slightly bent, the product will be scrapped. Machine vision inspection of the sealant and cooling gel position will enable automated rejection of incorrect parts, without having to stop the assembly line.
